Structural repair of Careva Ćuprija Bridge in Sarajevo

Professional paper

Structural condition and repair of the Careva Ćuprija Bridge in Sarajevo is presented in the paper. This historic structure has been exposed to various atmospheric influences during its use, and also to significant traffic load for which it was not initially designed, which has ultimately resulted in degradation of its structure. To enable continued functioning of this bridge its structure must be repaired taking into account the fact that the bridge was proclaimed a national monument of Bosnia and Herzegovina on 11 March 2009.

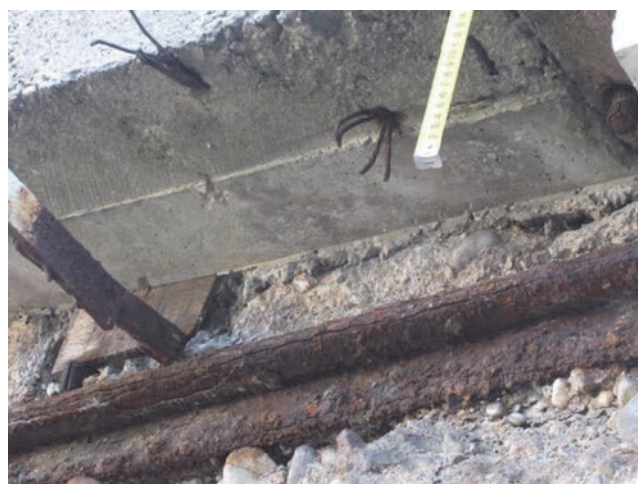
Figure 9. Corrosion of top rigid reinforcement - east façade-upstream side

The bridge extrados is made of concrete with rigid reinforcement, which is placed at the ends, on both sides of the bridge (Figure 9). After removal of the top layers of the bridge structure, it will be possible to see whether this reinforcement is placed along the entire width of the bridge, as is the case with the intrados, or it is placed on the sides only. Figure 9 shows significant corrosion of the top rigid reinforcement. This reinforcement is unprotected and is directly exposed to

weather, presenting significant "swelling" due to an increase in the volume of reinforcement, which indicates that the reinforcement has been greatly affected by corrosion. It is well known that parts of the structure on the east side are highly exposed to rain and wind, which has resulted in quicker degradation and impact.

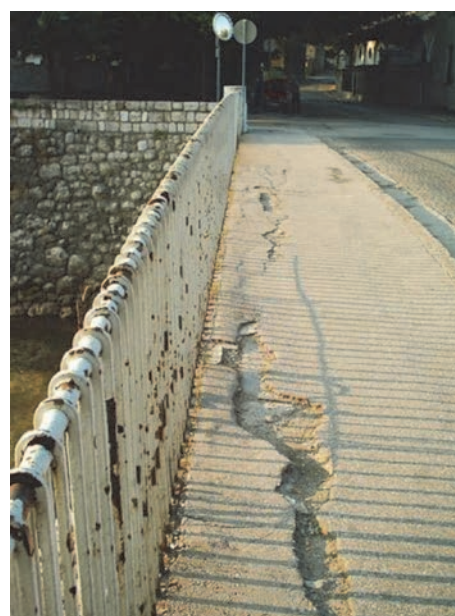
Figure 10. Corrosion of steel fence and sidewalk damage

The fence of the bridge is in a very poor condition (Figure 10); the entire structure of the steel fence is affected by corrosion. Also, spalling of concrete was observed on the sides of the bridge structure (east façade - upstream side of the bridge, and west façade - downstream side of the bridge) at the connection with S-shaped steel elements and their corrosion (Figure 11).

Figure 10 shows sidewalk degradation and lack of asphalt layer. Damage to sidewalk and railing is due to the freezing and thawing

processes. Once water is allowed to penetrate into the capillary system and it freezes, the pores and cavities are enlarged due to hydrostatic pressure, which is caused by an increase in the volume of frozen water. This pressure expands the pores and capillaries quite slowly, over a number of cycles. The damage due to freezing and thawing processes, in the form of sputtering and spalling of concrete, mainly resulting from progressive expansion of cement stone, was also registered. This freezing and thawing effect is greatly enhanced by the use of deicing salts, which are regularly used for road maintenance. This caused maximum spalling on the concrete surface. In the end, breaking and spalling of concrete led to exposure of reinforcement to corrosion due to penetration of chlorides and moisture.

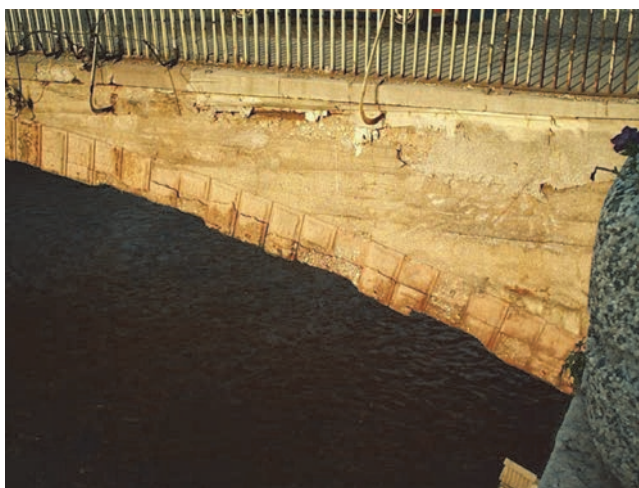
Figure 11. Detachment of decorative elements, horizontal cracks in concrete on the arch, and corrosion at the railing support - east façade - upstream side

A horizontal crack extending along the entire length of the sandstone lining can clearly be seen at the eastern façade (Figure 11). Due to great exposure to rain and wind action, this stone lining on the east façade suffered considerable damage, the level of which is greater compared to the damage registered at the western façade.

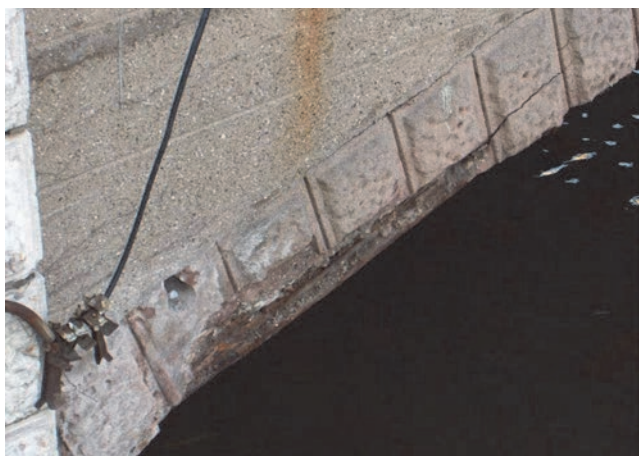
Figure 12. Horizontal cracks on the walls: east façade - upstream side

Figure 12 shows a significant horizontal crack that extends almost along the entire length of the arch on the lateral side. This crack does not affect only the decorative element but extends through the load bearing concrete structure of the arch. This is to be expected given the significant corrosion of the rigid reinforcement on the intrados. Also, vertical cracks are evident on lateral walls of the arch. Cracks generally increase the porosity of concrete and allow water, soluble salts, and chemicals to penetrate into concrete, and thus accelerate its destruction and open the way for further corrosion of the rigid reinforcement.

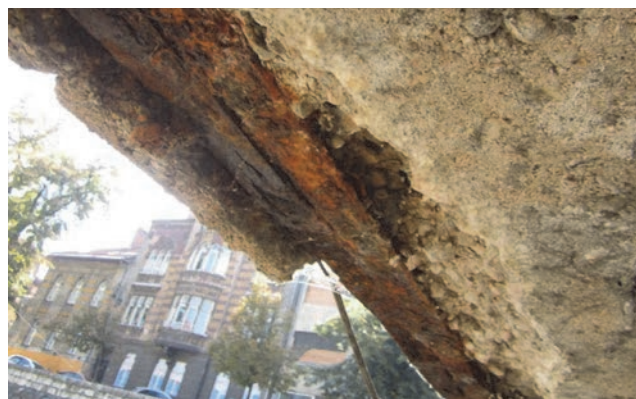
Figure 13. Corrosion of rigid reinforcement at bottom side of the arch - east façade - upstream

Significant corrosion at the bottom rigid reinforcement along the edge of the arch is shown in Figure 13, as well as the lack of concrete cover. As is known, concrete, thanks to its alkaline nature, protects steel reinforcement from corrosion. A high pH value enables formation of a thin protective layer of stable oxides on the steel surface, preventing further development of rust. When this protective layer of stable iron oxides is damaged by the action of acidic environment, the depassivation phenomenon inevitably occurs, i.e. the steel corrosion is initiated. The increase in reinforcement volume due to corrosion is evident, resulting in creation of internal stress, cracking and spalling of concrete. Longitudinal cracks are evident on the corroded "rigid reinforcement". Parts of rigid reinforcement that are completely "stripped" are exposed to active atmospheric actions, and so the structural capacity of these elements is compromised. This situation creates conditions for expansion of corrosion to the passivated part of rigid reinforcement.

The entire surface of the metal is affected by general corrosion, with additional subsurface or layered corrosion. The corrosion is the most pronounced at steel parts that have been in contact with water and acids.

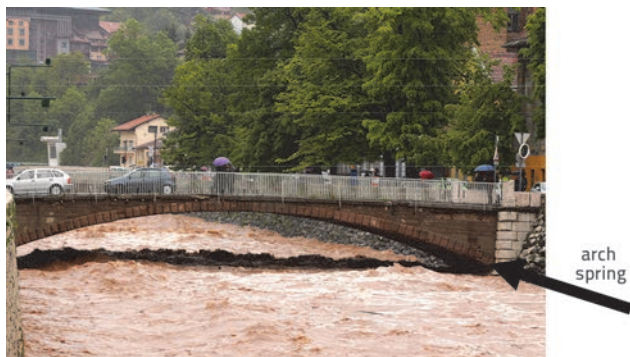
Figure 14. Flooding in May 2014

It should be noted that in the May 2014 flooding the level of the Miljacka River was the highest in the last ten years. It was 244 cm and the water reached the level of the arch spring (Figure 14), and so parts of the structure were directly exposed to the action of water. A similar situation, although at a smaller scale was registered in 31 October 2007. In the light of current information about the torrential character of the Miljacka River, the

question regarding safety of this bridge in case of a future flood should rightfully be considered. Besides destruction of the bridge materials due to torrential character of the Miljacka River, the river carries waste materials and debris and thus causes further damage to the bridge structure and the embankment of the Miljacka River. As it is well known, the scouring process differs if it occurs in water not burdened with sediments, compared to the scouring in rivers with significant bed load.

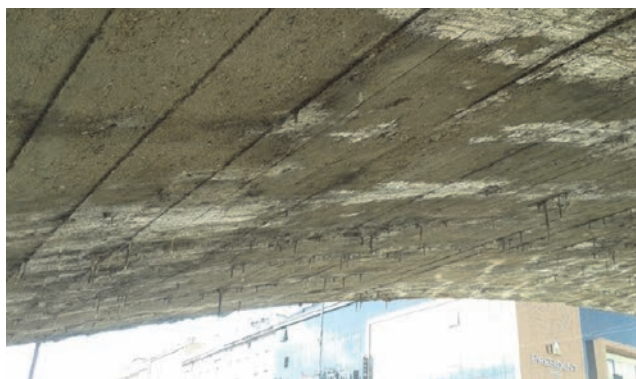
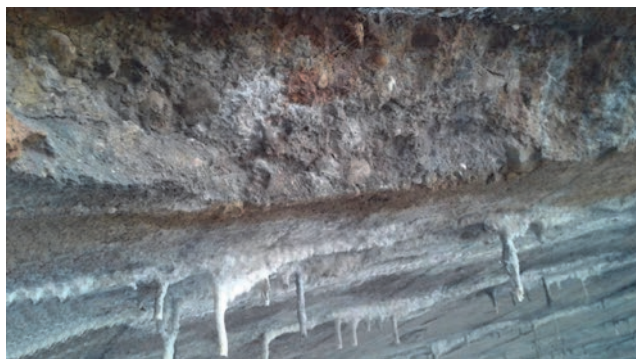
Figures 15 and 16 show that carbonation of concrete occurs when carbon dioxide from the air penetrates into the concrete and reacts with hydroxides, such as calcium hydroxide, forming carbonates. In the reaction with calcium hydroxide, calcium carbonate is formed. This process reduces the pH value of the solution within pores to less than 11.8 and, at that level, the passive iron oxide film on the steel becomes unstable, leading to corrosion. Carbonation is largely dependent on relative humidity. The greatest carbonation level occurs when the relative humidity is maintained in the range between 50 % and 75 %. Just like chloride ions, the carbonation destroys the passive film on the reinforcement, but has no effect on the corrosion rate.

Water from the carriageway penetrated through filling material to the concrete arch and caused flow-assisted corrosion (corrosion of soft water). It is known that on its way the seepage water dissolves calcium hydroxide (product of Portland cement hydration), which is deposited on the surface of the concrete where it reacts with CO_2 (carbon dioxide) contained in the atmosphere, forming a relatively solid, hard, well-adherent, bright coating of calcium carbonate (CaCO_3) appearing in form of downward oriented jets. Eventually, they spread and become thicker ruining the surface, and assuming the form of stalactites or stalagmites. Their formation is evident along the entire bottom surface of the bridge (intrados) in locations of rigid reinforcement. The stalactites are approximately 20 cm in length and about half a centimetre in diameter.

Figure 15. Carbonation of intrados and formation of stalactites

Figure 16. Carbonation of intrados and formation of stalactites

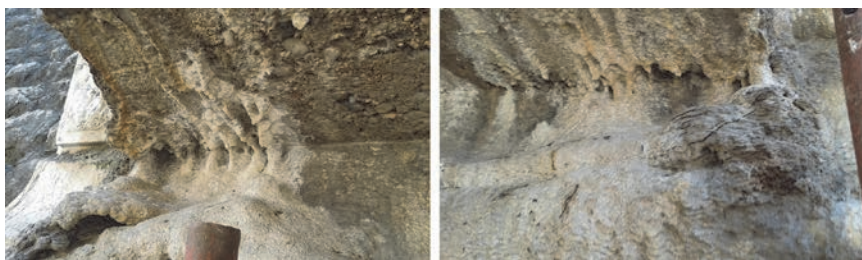
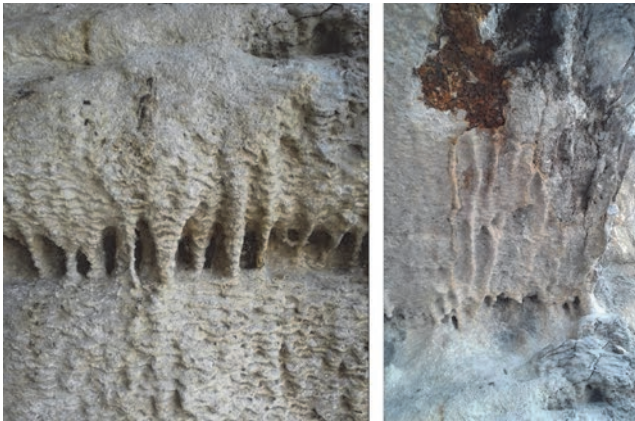
In addition to the flow-assisted corrosion, the concrete on this bridge is also exposed to general acid corrosion. General acid corrosion is formed by the action of from the environment CO_2 on the cement stone, which results in a chemical reaction. Carbon dioxide and water form carbonic acid which reacts with $\text{Ca}(\text{OH})_2$ forming CaCO_3 ; however other compounds of the cement stone decompose and water is released in the process. Therefore, the bridge is affected by soft water corrosion (flow-assisted corrosion) in combination with general acid corrosion. Figures 17 and 18 show formation of deposits on the abutment. This deposit is up to 20 cm in thickness and it peels off and separates from stone blocks that are placed around the abutments of the bridge structure. Figure 19 also clearly shows significant corrosion of rigid reinforcement near the left abutment on the downstream side. This corrosion penetrates through significant deposits that have formed as a result of corrosion release. The carbonation results in a decrease in concrete alkalinity.

Figure 17. Deposits at left abutment - east side

Figure 18. Deposits at left abutment - east side

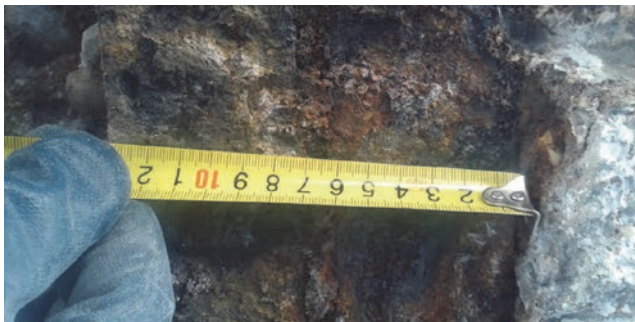
Figure 19. Rigid reinforcement

Figure 19 shows rigid reinforcement at the intrados. The rigid reinforcement consists of 2L sections measuring 60x60x4 mm, which are separated by a layer of concrete 1 cm in thickness. The overall width of the rigid reinforcement and concrete amounts to 13 cm. A significant corrosion was observed after removal of concrete cover (5 cm) (Figure 20). The steel peeling can clearly be distinguished. The degree of steel corrosion varies depending on the position of the rigid reinforcement and the existence or absence of concrete cover. Overall, it can be stated that the rigid reinforcement is highly corroded.

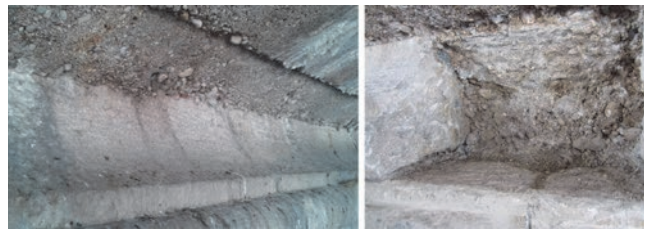
Figure 21. Abutment stone blocks at the left bank of the river and situation after their removal

After removal of stone blocks (Figure 21) at the location of left abutment, it was observed that the stone blocks serve exclusively as lining.

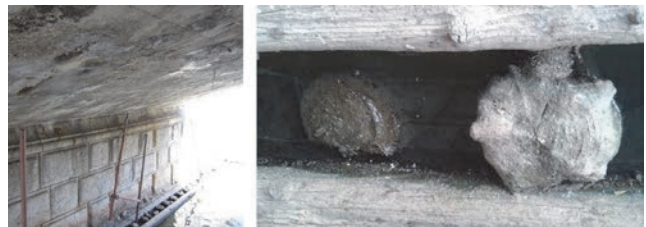
Figure 22. Wooden piles and beams along the Miljacka river bank

A part of the Miljacka river bank is protected by wooden beams and piles placed between two beams (Figure 22). Wooden piles are of variable diameter ranging from approximately 10 cm (smaller) to 30 cm (bigger ones). They are spaced at approximately 50 to 80 cm from each other. As investigations were conducted in dry period (August 2015), it was noted that wooden piles are not fully covered with water, but are free of water some 5-8 cm.

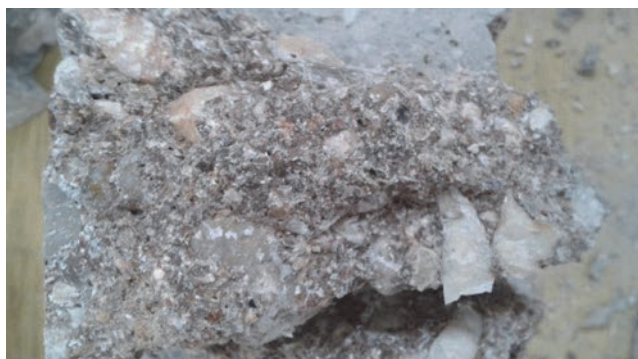
Figure 31. Seepage through concrete

occurs at the location where these samples were extracted. Due to the soft water seepage, capillaries are being filled, which is manifested by concrete coagulation and increase of density in hardened state. The values of density (2142 kg/m³ and 2134 kg/m³) and compressive strength on the cube (37.0 MPa and 39.5 MPa) greatly deviate from all other similar results [8]. Water seepage through concrete is characterised by uneven filtration: the number of filtration channels is the greatest at the beginning of the filtration path, next to concrete surface exposed to pressure. Blockage of filtration occurs due to hydrolytic decomposition of cement stone and swelling of colloidal compounds (mostly calcium hydrosilicate). The process of leaching is significantly slowed down only if the layer depleted and weakened by leaching of lime, which is formed on the surface of concrete, does not fall apart due to mechanical or hydraulic effects (Figure 30). Significant corrosion of concrete can be observed on all samples (Figure 31).
